## **Tech Note**

SI B 12 04 00

SUBJECT

Secondary Air System Faults

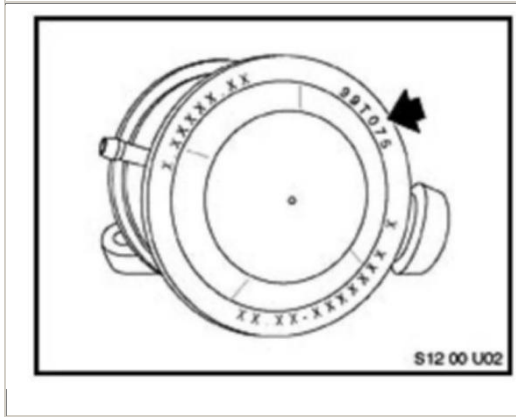
A Non-return valve with a dated code stamping as of 99T075 (arrow) and later is the improved version. date cose explanation: 99=year, T=day, 075=75th day of the year.

Only the improved non-return valves are available from the Parts Distribution Centers.
