XT303-06

X-TYPE

Driveability Issues/MIL Illuminated - Chafed Wires at A/C Pressure Switch - Repair Procedure

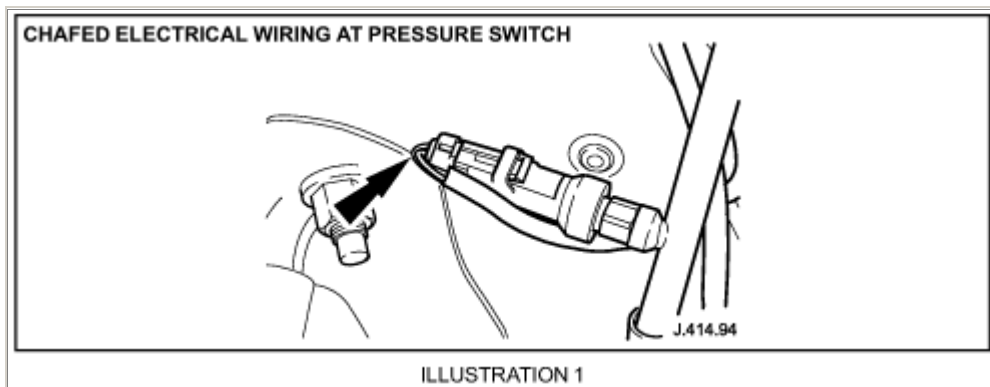
6. Inspect air conditioning pressure switch wiring for fouling/chafe condition and damage. (Illustration 1)  
**Note:** If damage to wiring has been identified, disconnect electrical connector and continue from step 7. If there is no damage to wiring, disconnect electrical connector and continue from step 16.
7. Displace anti back-out device from air conditioning pressure switch electrical connector.
8. Displace cover from rear of air conditioning pressure switch electrical connector.
9. Displace chafed wire from air conditioning pressure switch electrical connector.
10. Cut heat shrink sleeve from harness repair kit to appropriate length to cover chafe in wire

11. Install heat shrink sleeve over chafed wire.
12. Apply appropriate heat source to heat shrink sleeve.
13. Install and push fully home repaired wire into air conditioning pressure switch electrical connector.
14. Align and fully install air conditioning pressure switch electrical connector rear cover.
15. Align and fully install air conditioning pressure switch electrical connector anti back-out device.
16. Using appropriate de-greaser, clean body around area where the fouling/chafe condition has been identified.  
**Note:** Allow area to dry.
17. Remove backing strip from PTFE protection pad.
