# Diversified Environmental Catalysts

## Tech-Note

01-014/04

MIL ILLUMINATION WITH  
DTCS P0300 P0301 P0302 P0303 P0304 P0305 P0306 P0171  
P0174 P1170 P1173 STORED IN MEMORY

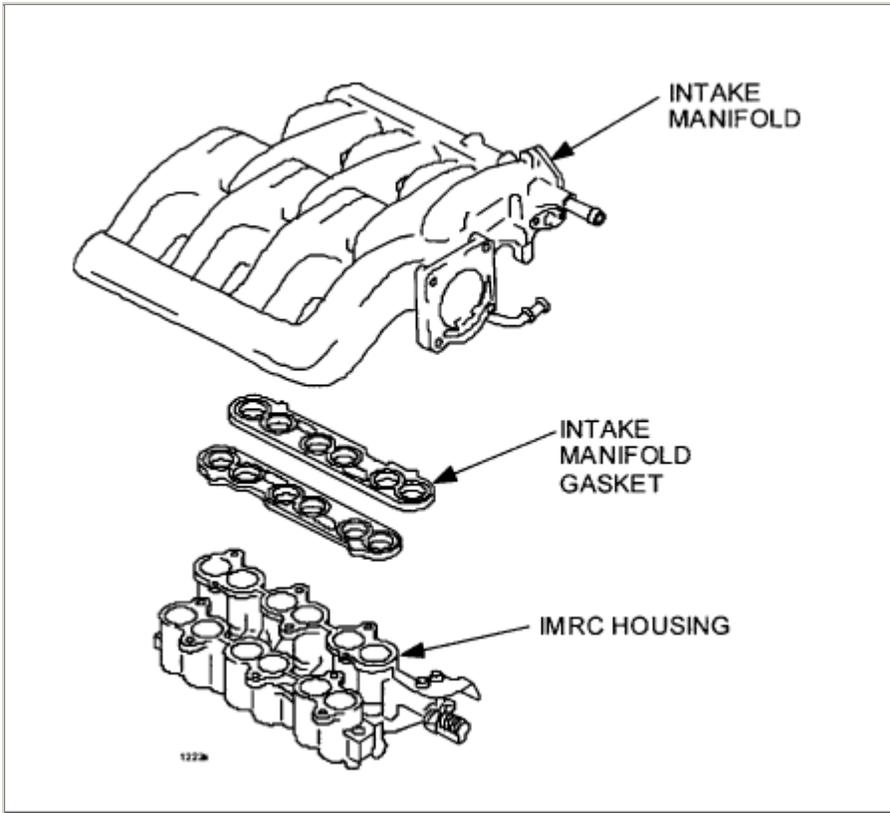
The sealing of the intake manifold gasket may be deteriorated, causing air leakage. The sealing material of the gasket has been modified to eliminate this concern.

1. Verify concern.
2. Inspect intake manifold area for air leakage.
  - ^ If air leak is found, replace intake manifold gaskets with modified parts according to the MPV Workshop Manual (section 01-13) INTAKE-AIR SYSTEM REMOVAL/INSTALLATION
  - ^ If air leak is not found, troubleshoot DTC(s) according to appropriate section of the workshop manual.
