PI1296: Diagnostic Tip for Engine Misfire and/or Popping Noise on Cold Startup after Cylinder Head or Fuel Rail/Injector Repair - (Aug 19, 2014)

Models: 2009-2015 Buick Enclave Models  
2010-2015 Buick La Crosse, Allure (Canada)  
2008-2011 Cadillac STS  
2009-2015 Cadillac CTS Models  
2010-2015 Cadillac SRX  
2013-2015 Cadillac ATS, XTS  
2009-2015 Chevrolet Traverse  
2010-2015 Chevrolet Camaro, Equinox  
2012-2015 Chevrolet Captiva, Impala  
2015 Chevrolet Colorado  
2009-2015 GMC Acadia Models  
2010-2015 GMC Terrain  
2015 GMC Canyon  
2009-2010 Saturn OUTLOOK  
Equipped with HFV6 Engine RPOs LF1, LFW, LFX, LLT, LF3 or LFR

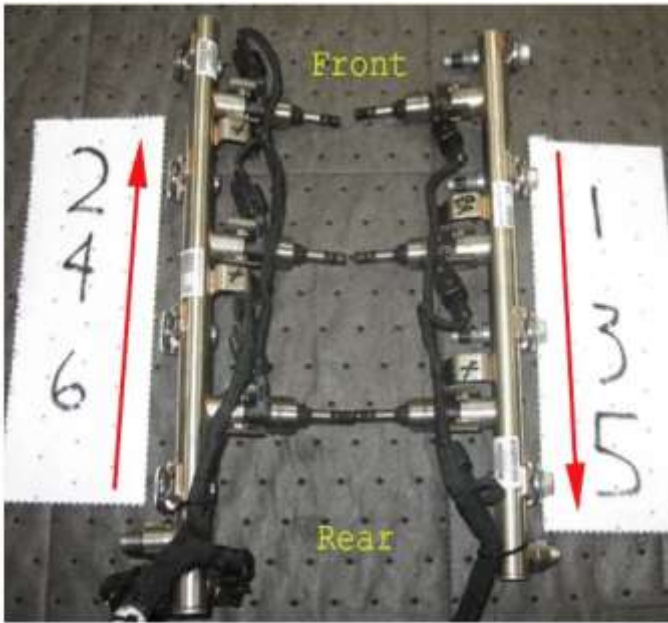
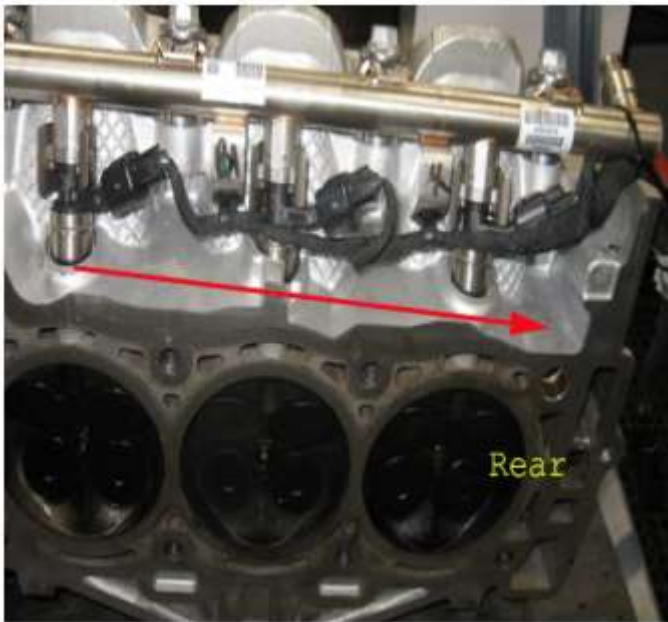
^ Bank 1 injector connectors aim toward the rear of the engine as shown.

Verify the orientation of the fuel injectors. Refer to Fuel Injector Fuel Rail Assembly Replacement in SI.

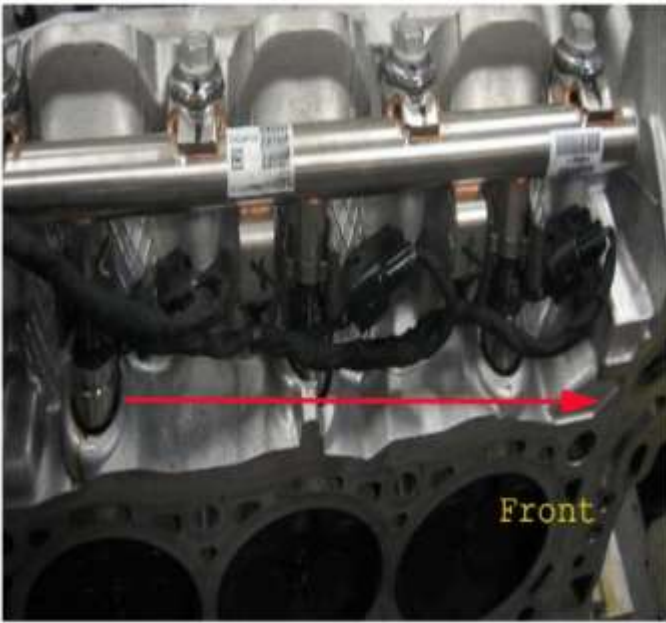
^ Bank 2 injector connectors aim toward the front of the engine as shown.
